***Combustion 2000***  
***Phase II***

**Quarterly Progress Report**

**October 1 - December 31, 1999**

**United Technologies Research Center  
411 Silver Lane, East Hartford, Connecticut 06108**

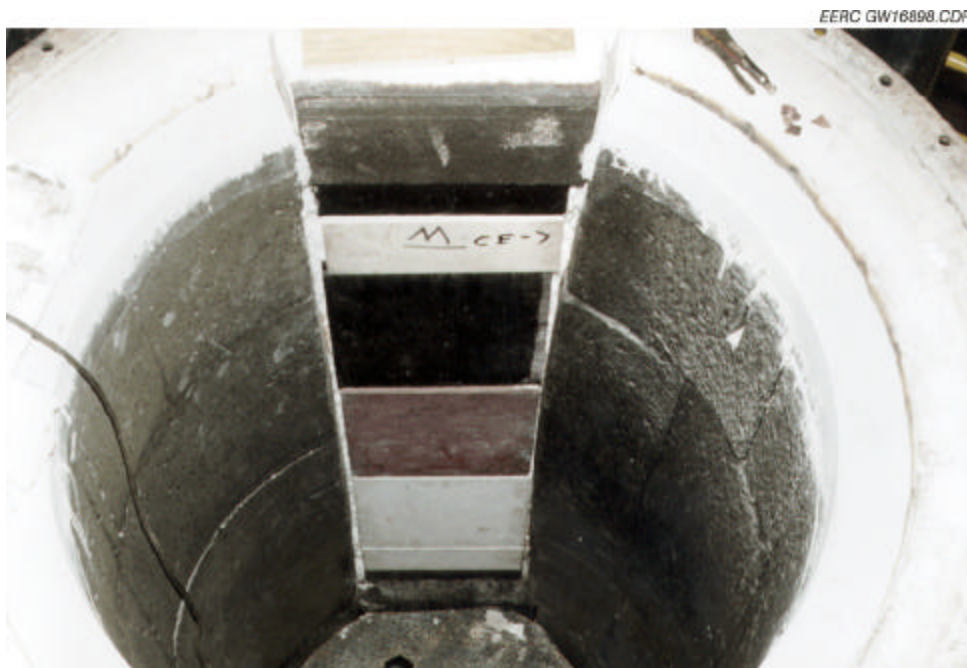
**Exhibit 2-6**  
**Photograph of Furnace Interior Prior to the December Test, SFS-RH11-0799**

The high-density refractory lining the furnace was found to be in excellent condition following the September test. The new slag screen inlet design, with rounded edges on the sides, appears to have minimized erosion, in spite of a high auxiliary burner firing rate. However, as a result of further densifying/shrinkage of the high-density refractory layer in the furnace, it was necessary to add 2 in. (5 cm) of high-density refractory to the top of the main furnace section prior to the December test in order to avoid exposing the intermediate refractory layer to furnace operating temperatures. Exhibit 2-6 presents a photograph of the interior of the furnace showing the new refractory layer at the top of the main furnace section, the continued darkening of the furnace walls seen following each coal-firing period, and the RAH tiles installed prior to the December test.

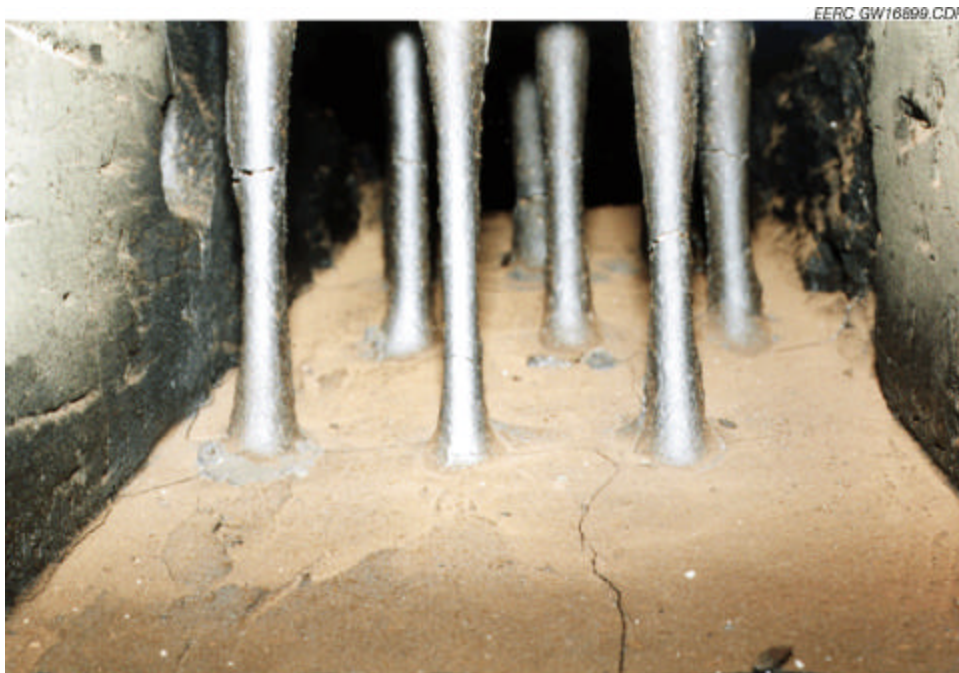
**Exhibit 2-7**  
**Photograph of the Slag Screen Inlet Following the September Test,**  
**SFS-RH10-0699**

Exhibit 2-7 is a photograph of the slag screen inlet following the September test. The first row of slag screen tubes have experienced a substantial loss in mass, measuring only about 0.75 in. (1.9 cm) in diameter at the smallest point, from a starting diameter of 1.5 in. (3.8 cm). However, the December SFS test used Illinois No. 6 coal as the fuel, and EERC experience shows that a layer of slag tends to build up on the tubes with this fuel. Therefore it was not necessary to replace any of the slag screen tubes before the December test period. Operation with the three existing rows of tubes (nine tubes total) has proven satisfactory with the Illinois No. 6 fuel. However, prior to firing a subbituminous coal in

February 2000, the EERC plans to rebuild the slag screen, installing 18 tubes in six rows of three. In addition, EERC personnel will review past experience with subbituminous and lignite fuels in order to select the appropriate size for the water-cooled center tubes.

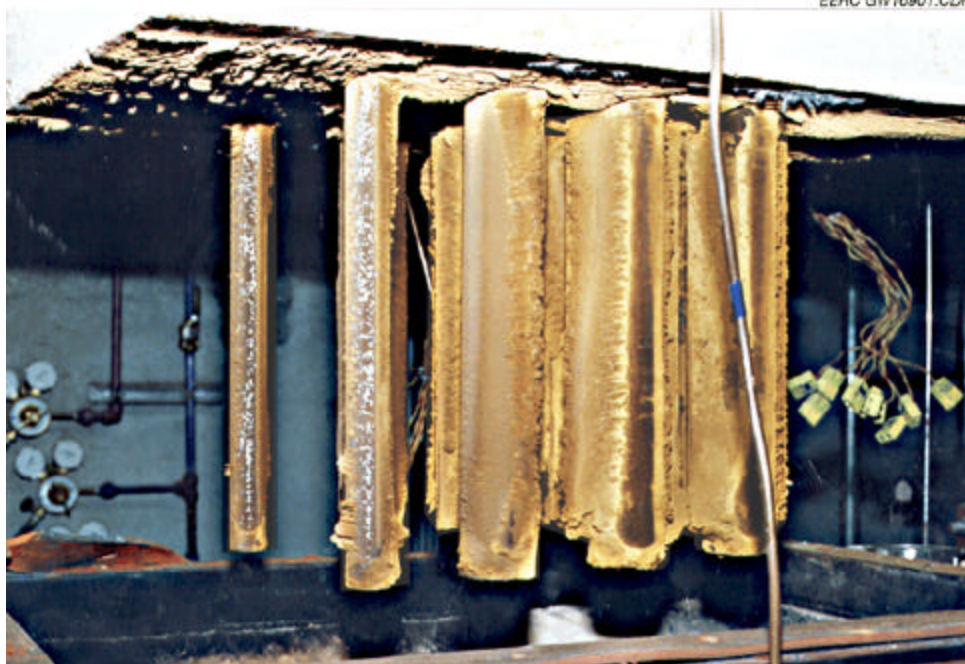
### **Photograph of Ash Deposits on the CAH tubes Following the September Test Firing Prater Creek Bituminous Coal**

EERC personnel did not clean the CAH tube bank during the September test, and ash deposits were not characterized because of the limestone injection that occurred for several hours at the beginning of the test. The deposits that formed were limited to the leading and trailing edges of the tubes. Exhibit 2-15 presents a photograph of ash deposits on the surface of the tubes following the September test. The photograph shows three of the five uncooled tubes as well as two of the seven air-cooled finned tubes. Leading- and trailing-edge deposits are visible. However, the ash deposit mass appears limited and inconsistent with bare metal surfaces visible on areas of both uncooled and cooled tubes. Most of the leading edge deposit is missing from the first two uncooled tubes, having either sloughed off during the test or fallen off upon cooldown or removal of the tube bank from the duct.

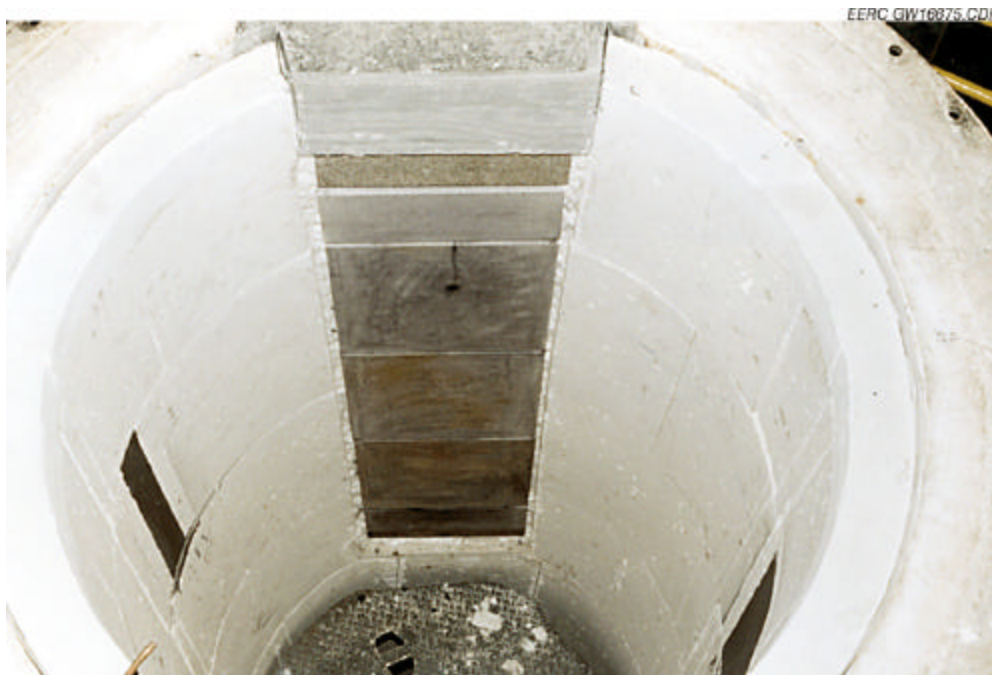
**Exhibit 2-16**  
**Photograph of New Ceramic Tiles Installed on the RAH Panel Inside of the**  
**Slagging Furnace in January 1999**

The RAH panel ceramic tiles were thoroughly inspected upon initial installation in January 1999 and following the September test period. The initial inspection revealed the presence of minor cracks in two of the five ceramic tiles. Cracks were not visible in either the top or bottom support blocks. Exhibit 2-16 is a photograph of the new ceramic tiles installed on the RAH panel inside the slagging furnace prior to the January 1999 test. The cracks visible at the time were hairline cracks in the large upper and lower tiles. The large upper tile had five visible cracks originating from the left edge and one crack originating from the top edge. Cracks originating from the left edge were about 0.75 in. (1.9 cm) in length and are not visible in the photograph. The vertical crack is visible in the photograph due to the application of a blue dye. In addition, rough surface pitting of the tile is evident at the end of the vertical crack in the upper center of the tile. The large lower tile had one crack originating on the left edge and a few rough surface pits along the right edge near the middle of the tile. Neither the crack nor the surface pits in the large lower tile are visible in the photograph.
